NACA TN No. 1492

AN INVESTIGATION OF FRETTING CORROSION UNDER
SEVERAL CONDITIONS OF OXIDATION

By B. W. Sakmann and B. G. Rightmire

Massachusetts Institute of Technology

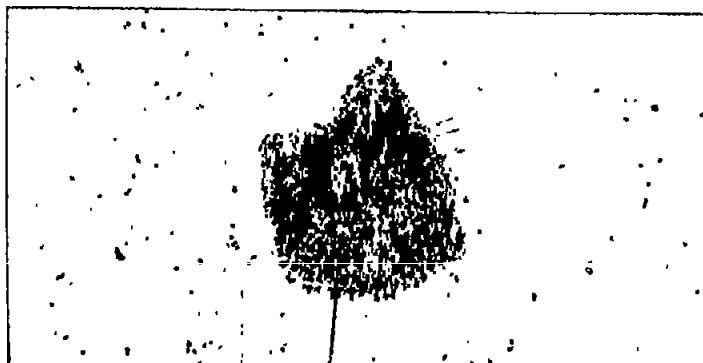
(a) Lead hemisphere after test in air of atmospheric pressure.

(b) Lead hemisphere after test in vacuum. Wear spot highly polished.

(c) Steel flat after test in air.

(d) Steel flat after test in vacuum.

Figure 11.- Lead hemisphere run against SAE 1020 steel flat in air and vacuum. Magnified 50 times.

The fourth pair of materials tested was a combination of lead on steel. On the old apparatus, it had been found that this combination had very good corrosion properties. Figures 11(a) and 11(b) show lead hemispheres after test in air and in vacuum, respectively. The corroded spot on the hemisphere run in vacuum was highly reflecting; this indicated that no oxidation took place. The corresponding spots on the steel flats are shown in figures 11(c) and 11(d). The two tests in air and in vacuum did not show any appreciable difference inasmuch as no serious damage was done to the steel flat in either case. The material transferred from hemisphere to flat under either condition could be wiped off with a cloth. Although lead oxide is rather hard, having a hardness value of 5 to 6 on Moh's scale, the combination of lead on steel has favorable properties. This is probably due to the fact that during the test the hard oxide fragments were embedded in the soft lead and were thus prevented from damaging the steel surface.
